BEACH EROSION CONTROL STUDY
OF
DOLLIVER NECK
GLOUCESTER, MASSACHUSETTS

5 March 1965

U. S. ARMY ENGINEER DIVISION, NEW ENGLAND
CORPS OF ENGINEERS
WALTHAM, MASSACHUSETTS

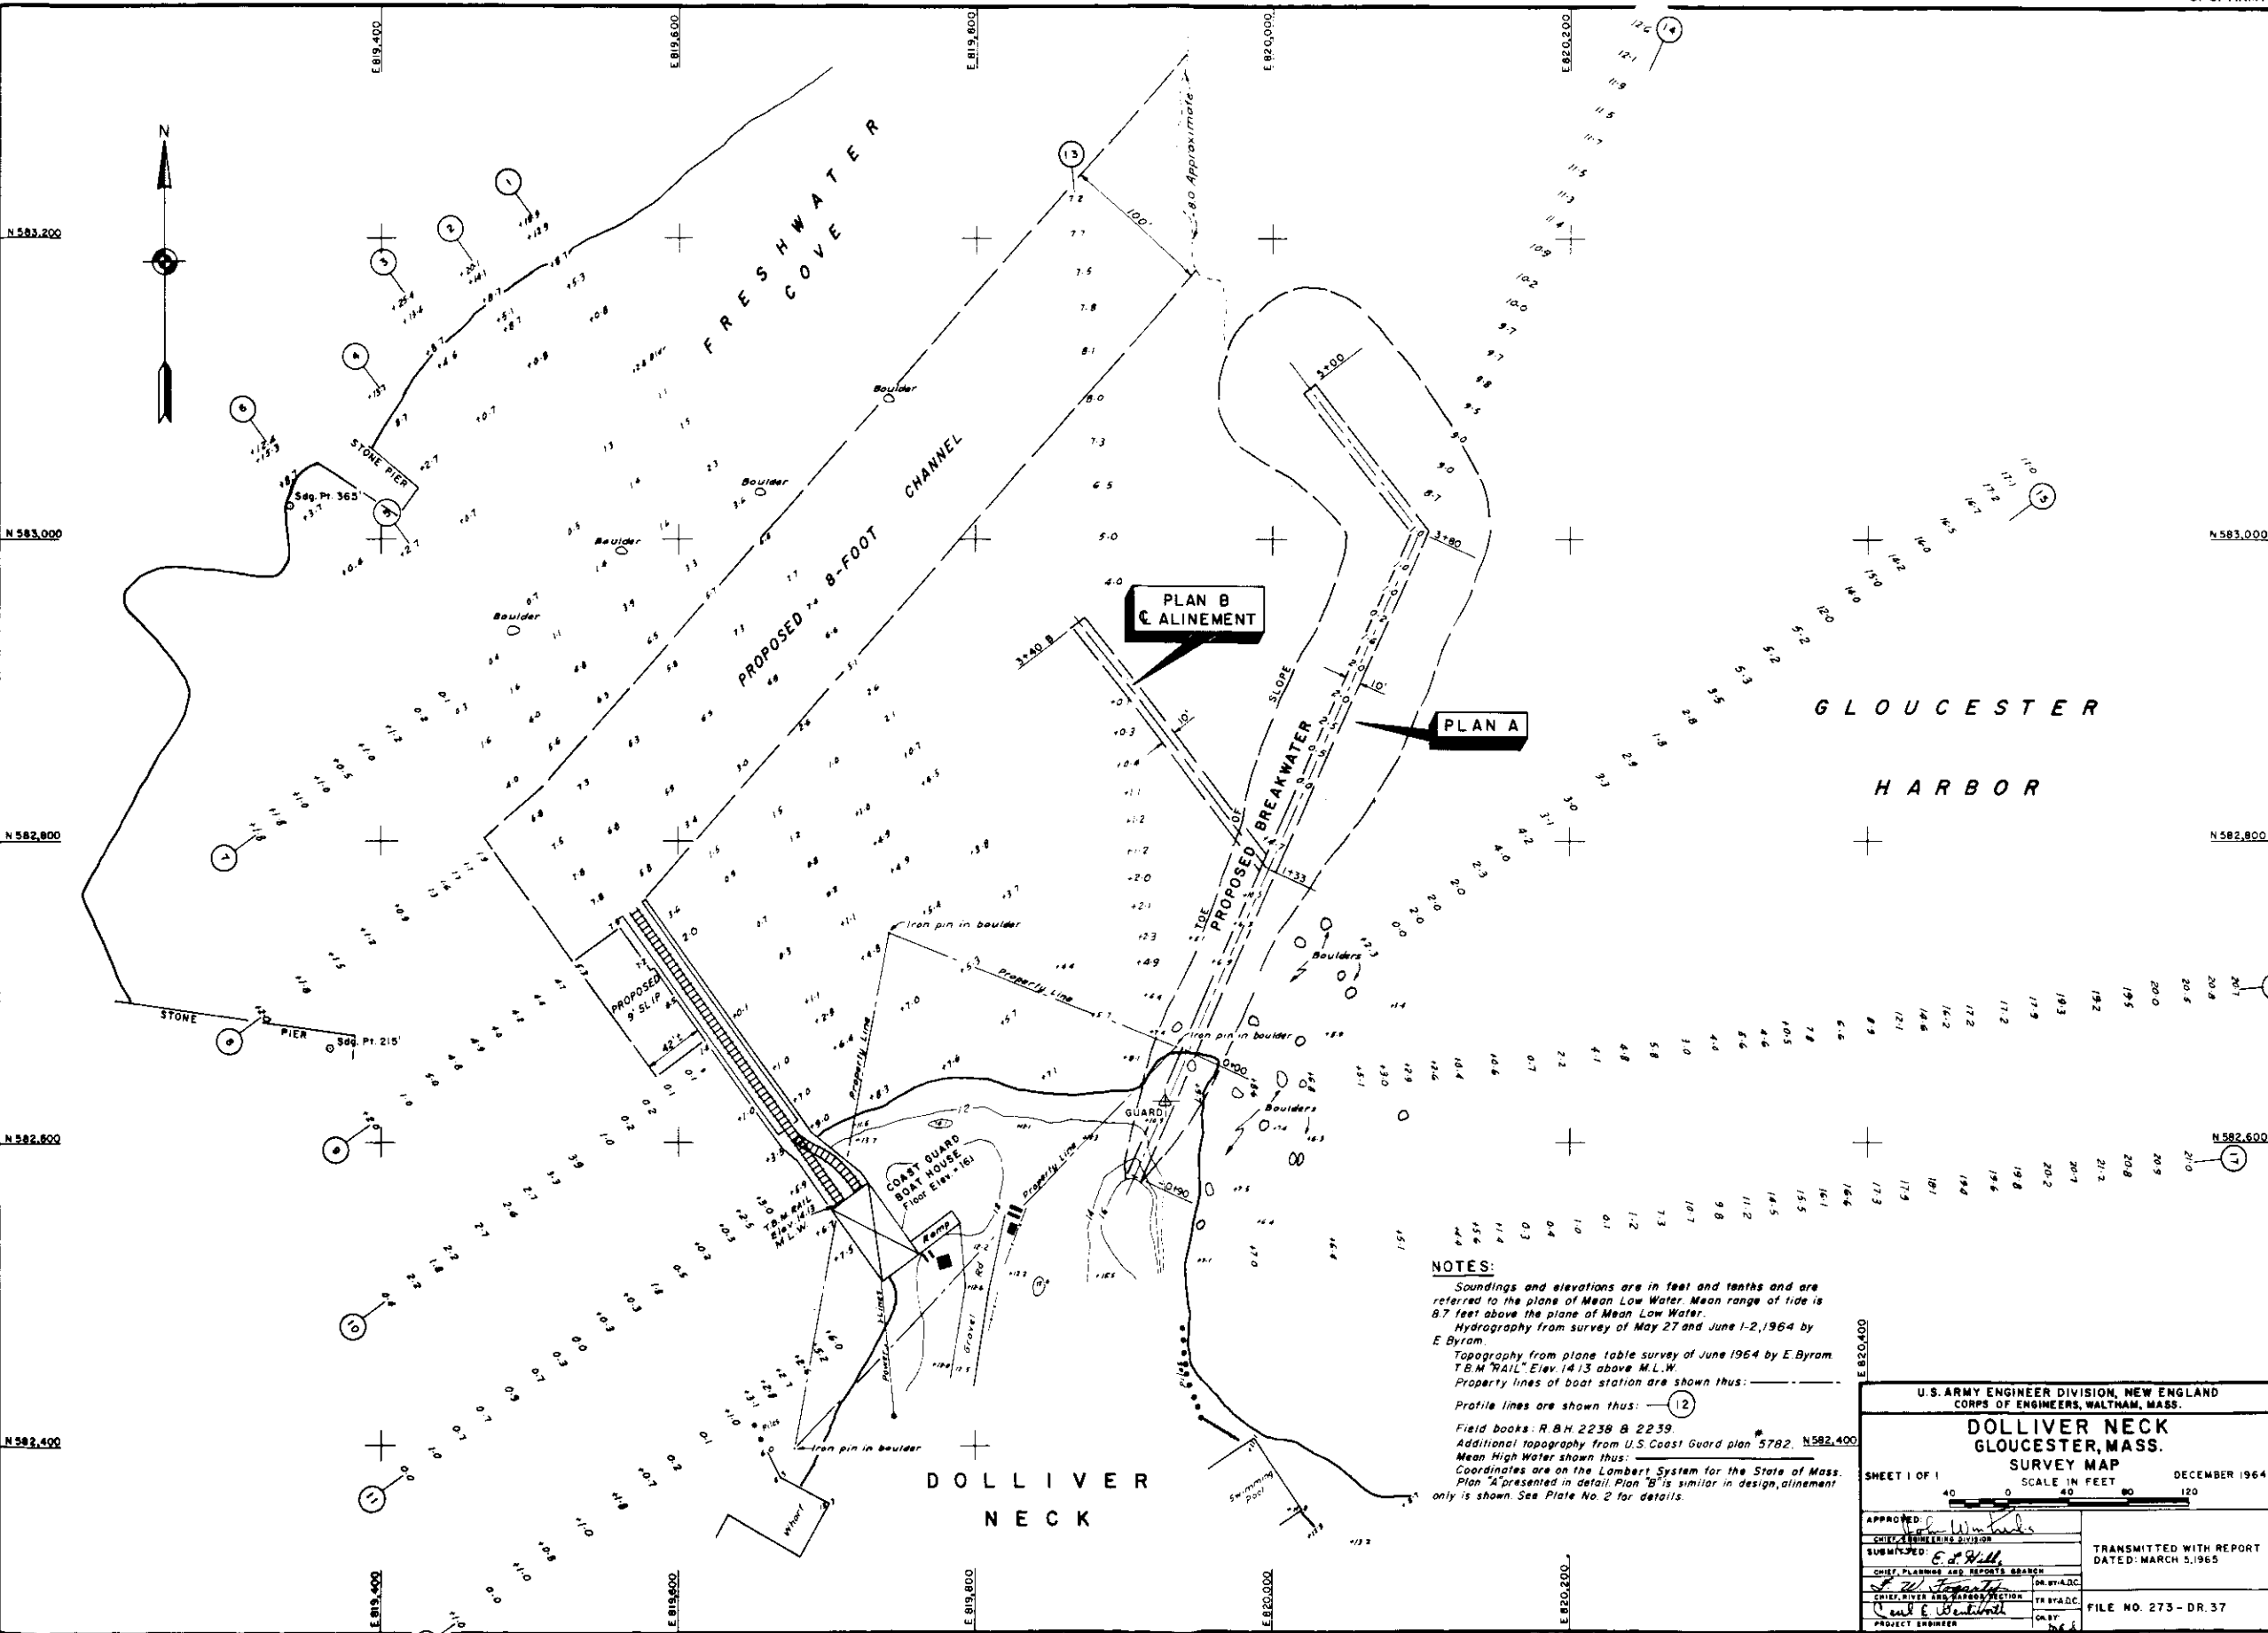
NOTES:
Soundings and elevations are in feet and tenths and are referred to the plane of Mean Low Water. Mean range of tide is 8.7 feet above the plane of Mean Low Water.
Hydrography from survey of May 27 and June 1-2, 1964 by E. Byram.
Topography from plane table survey of June 1964 by E. Byram.
T.B.M. "RAIL" Elev. 141.3 above M.L.W.
Property lines of boat station are shown thus: ————
Profile lines are shown thus: —(12)—
Field books: R.B.H. 2238 & 2239.
Additional topography from U.S. Coast Guard plan 5782, N582,400.
Mean High Water shown thus: ————
Coordinates are on the Lambert System for the State of Mass.
Plan "A" presented in detail. Plan "B" is similar in design, alignment only is shown. See Plate No. 2 for details.

12. Description. - A topographic and hydrographic survey was made for the area as shown on Plate 3. Detailed sounding information in combination with the overall physical features as shown on Plate 1 were utilized in formulating the plans of protection.
